## Investigations at the McDonald-Peavey House, 13620 95th St. S.E., Otsego, Wright County, MN.

Prepared for the City of Otsego

by Richard Rothaus, PhD

25 January 2012

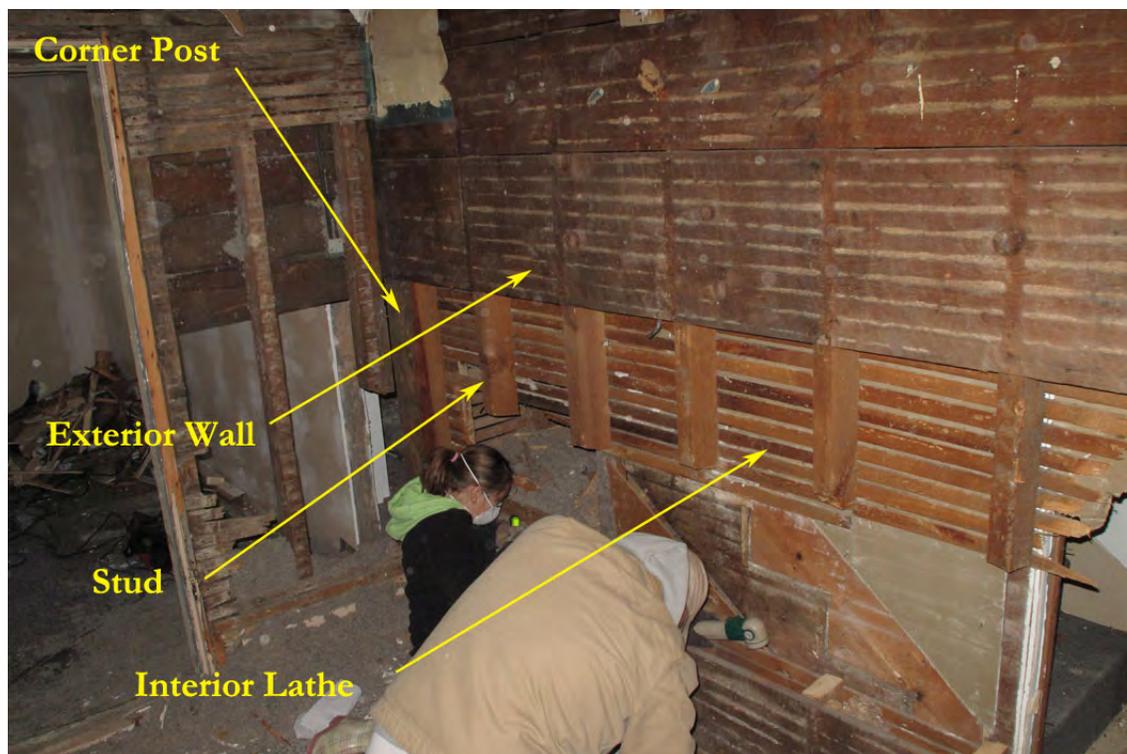
*Framing:* The structure is balloon framed. Lumber is dimensioned rough-cut. Corner posts were 2x4s; studs were 2x4s. Posts and studs extend up and into top floor. The SE corner of the structure has been heavily repaired, probably indicating some structural damage in this part of the house. The repair is late (post-1970s), based on lumber, nails, and associated floor replacement.

Figure 9: Phase I, West Wall, Looking NE (sample from this location by the Otsego HPC)

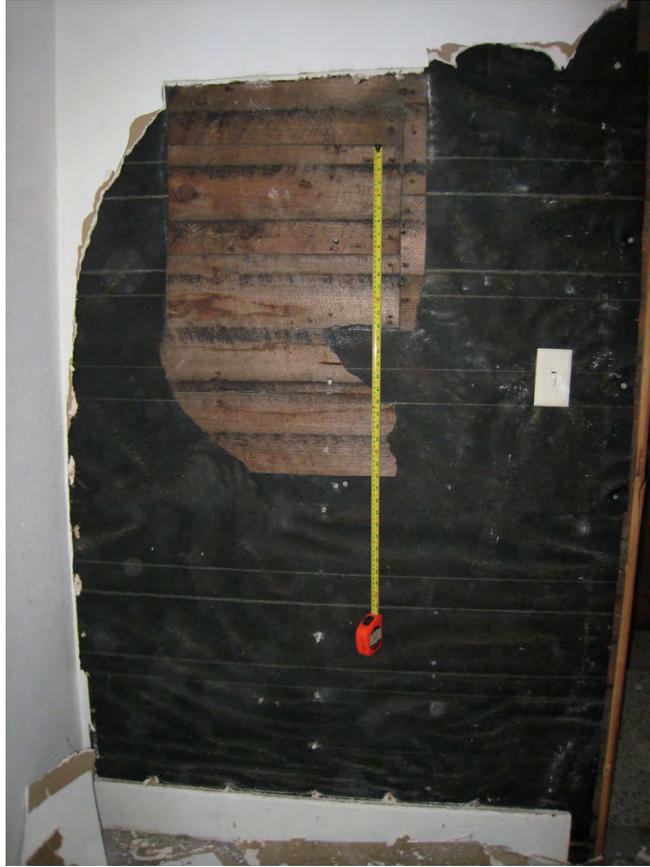
*Exterior Finish:* The exterior wall sheathing was covered with tar paper and shingles were added. Tar paper remnants were found, but no shingles were preserved. Use of shingles was determined by the presence of numerous shingle nail holes that predate all other exterior finishes.

Figure 10: Phase I Exterior Wall Sheathing and Tar Paper

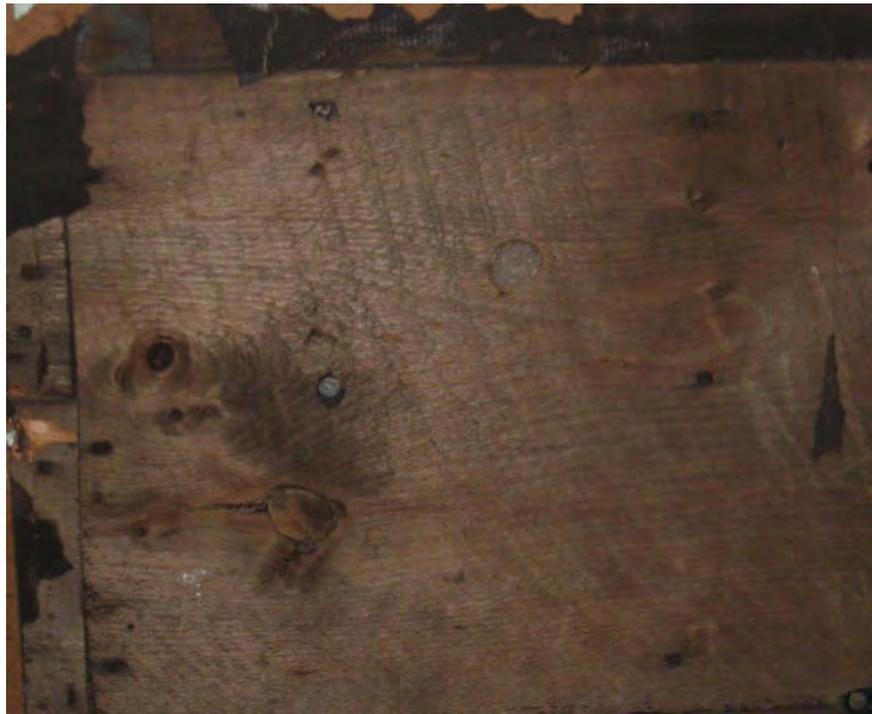
*Walls:* The exterior walls were wide planks of varying dimensions, rough cut with a circular saw. The interior walls were a narrow closely spaced lathe and plaster. Wall board dimensions were quite large; the largest noted in this investigation was 18" x 13'. Rock wool insulation was used in the original walls.

Figure 11: Phase I Wall Sheathing, Circular Saw Marks

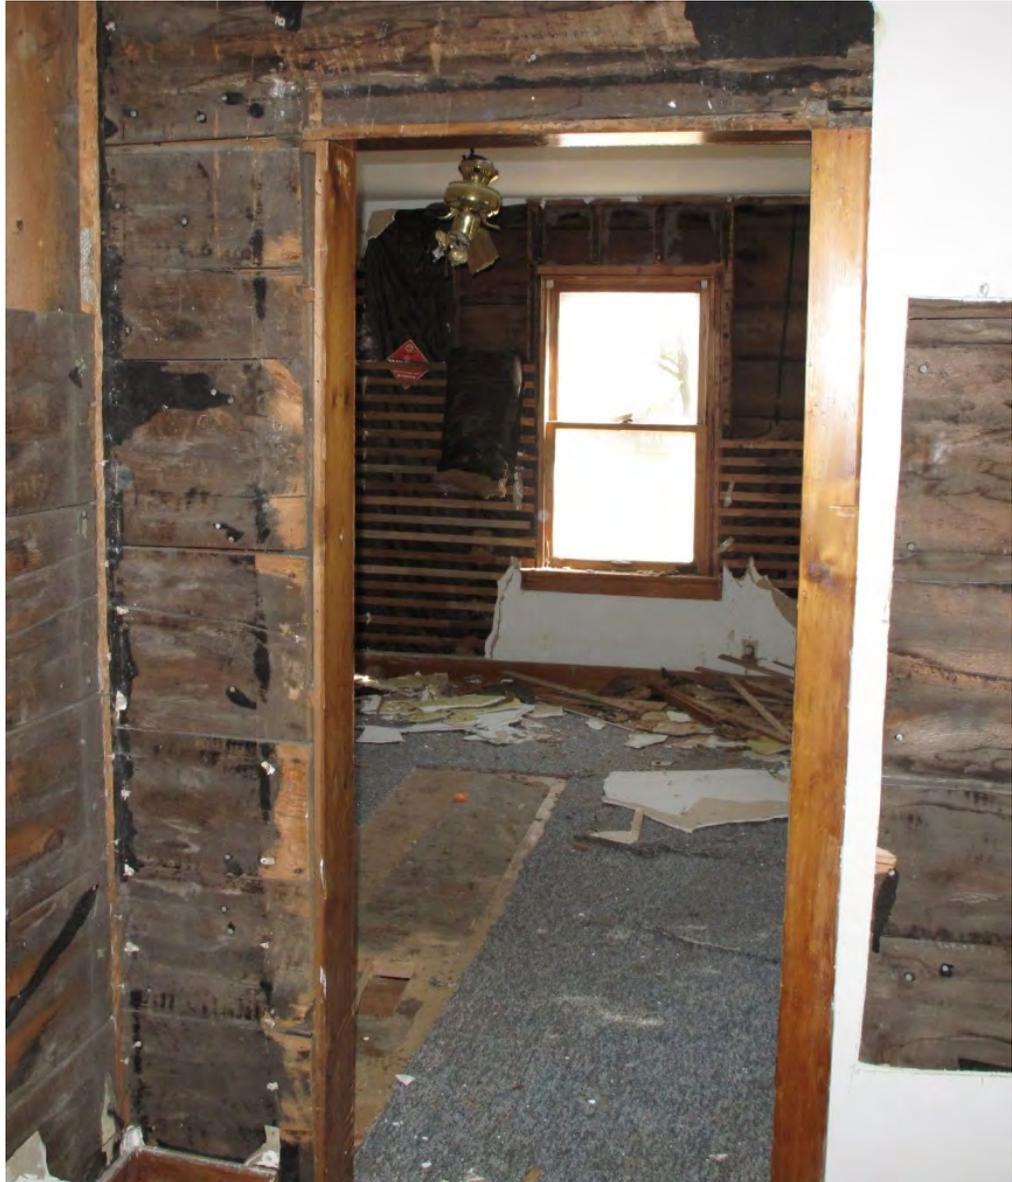
*Doors:* The structure had two exterior doors, one on the south wall (east corner), and one on the west wall (center). The west wall door had notches (approximately 1 3/4"x2") above the door frame. The notches were cut through the exterior sheathing into the frame headers and were presumably to support a porch hood over the doorway. This door was 37" wide and 81" high.

Figure 12: Phase I West Door

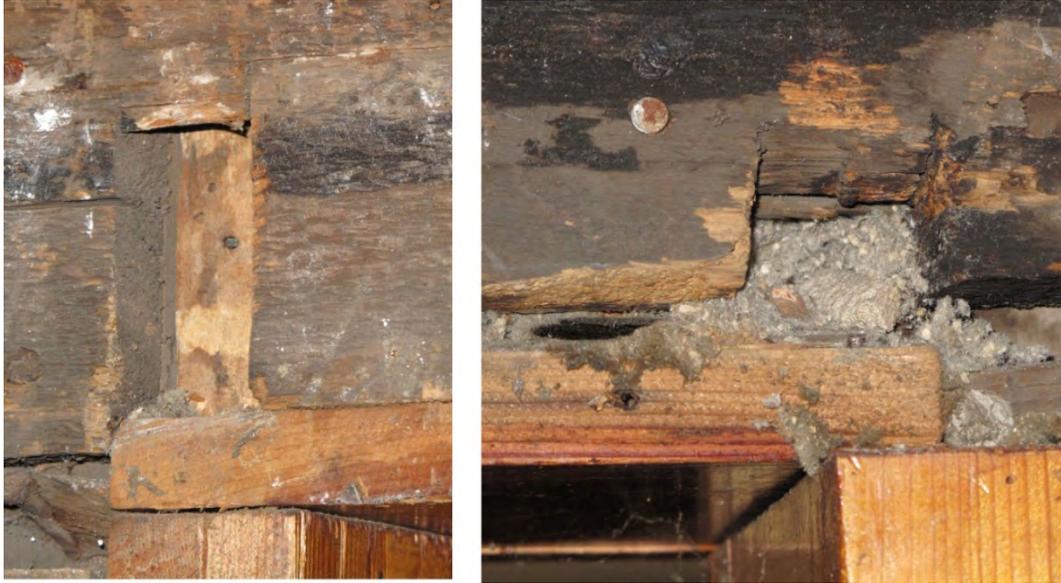
Figure 13: Phase I West Door Hood Notches

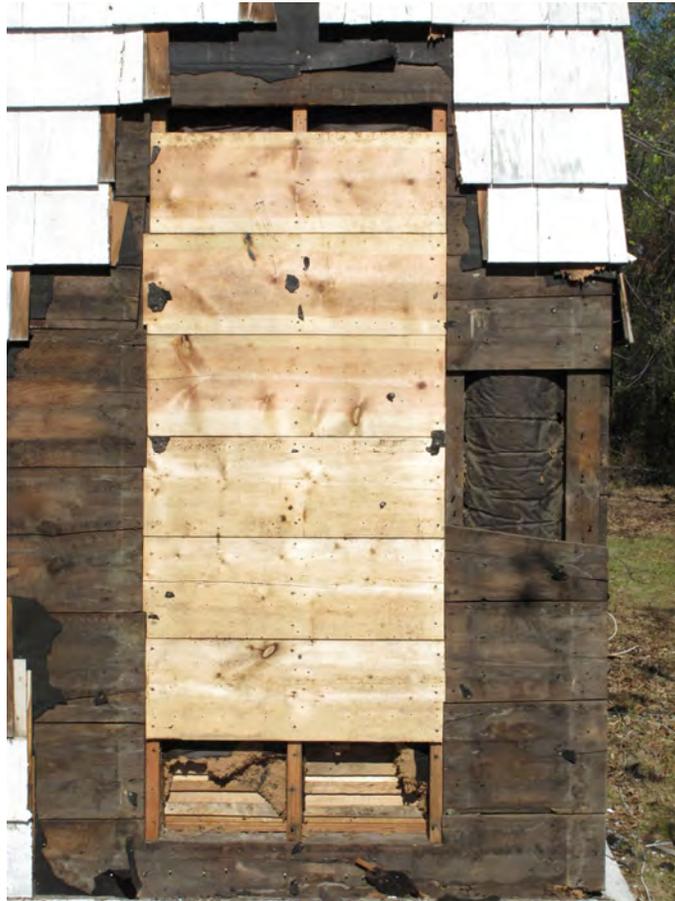
The south wall door was 84 3/4" x 34 3/4". The south wall door was infilled recently, probably at the time of the 1970s reconstruction.

Figure 14: Phase I South Door (Infilled)

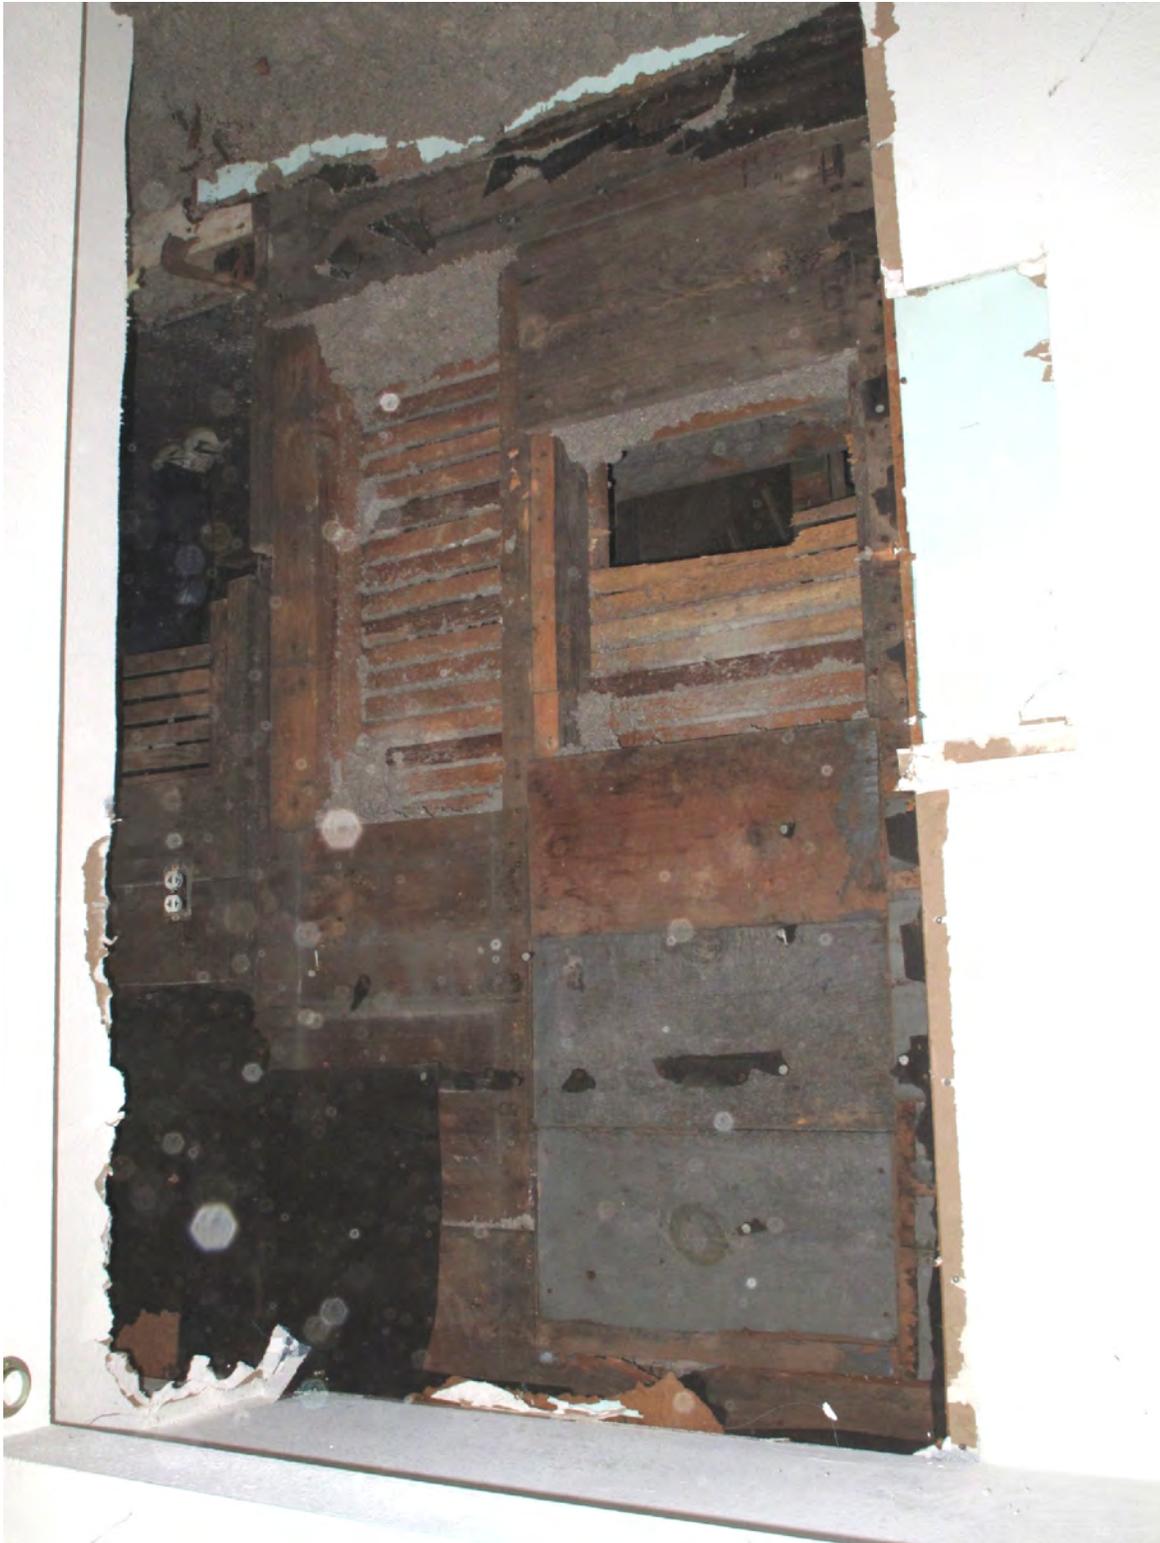
There is also evidence of a third door in the north side (west corner) of the house. This door was infilled with rough cut wide planking. The date of this door and the infilling could not be determined. The door conflicts with the stairwell and may represent an earlier phase of the building when the stairwell was placed elsewhere.

Figure 15: Phase I North Door (Infilled)

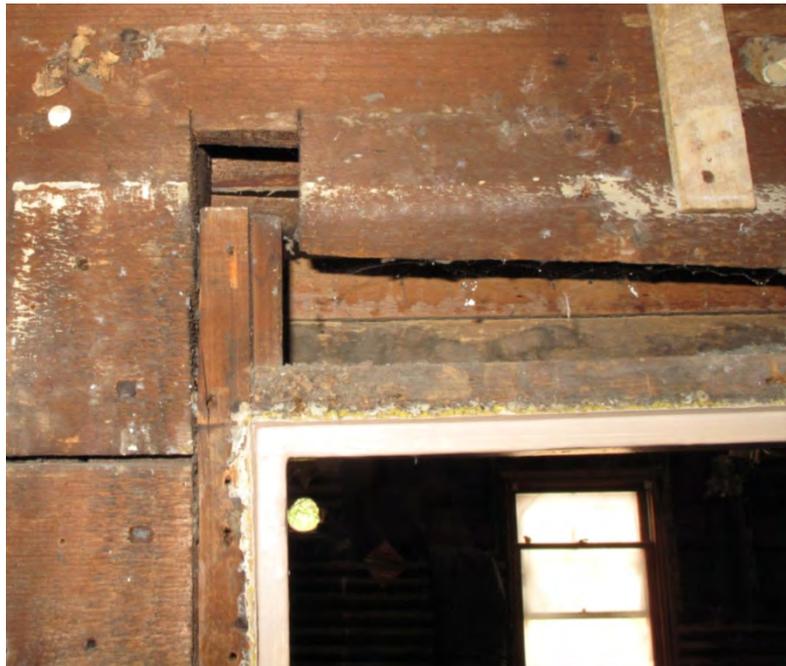
*Windows:* Windows were present on all walls downstairs, and one the north and south walls upstairs. All windows had been replaced or infilled, and original window styles have not been determined. Original window size was approximately 38"x32". The size of the windows suggests that they were multipaned. The west wall window had porch hood attachment notches like those over the west door. This suggests a set of matching porch hoods.

99999Figure 16: Phase I Hood Attachment Notch, West Window

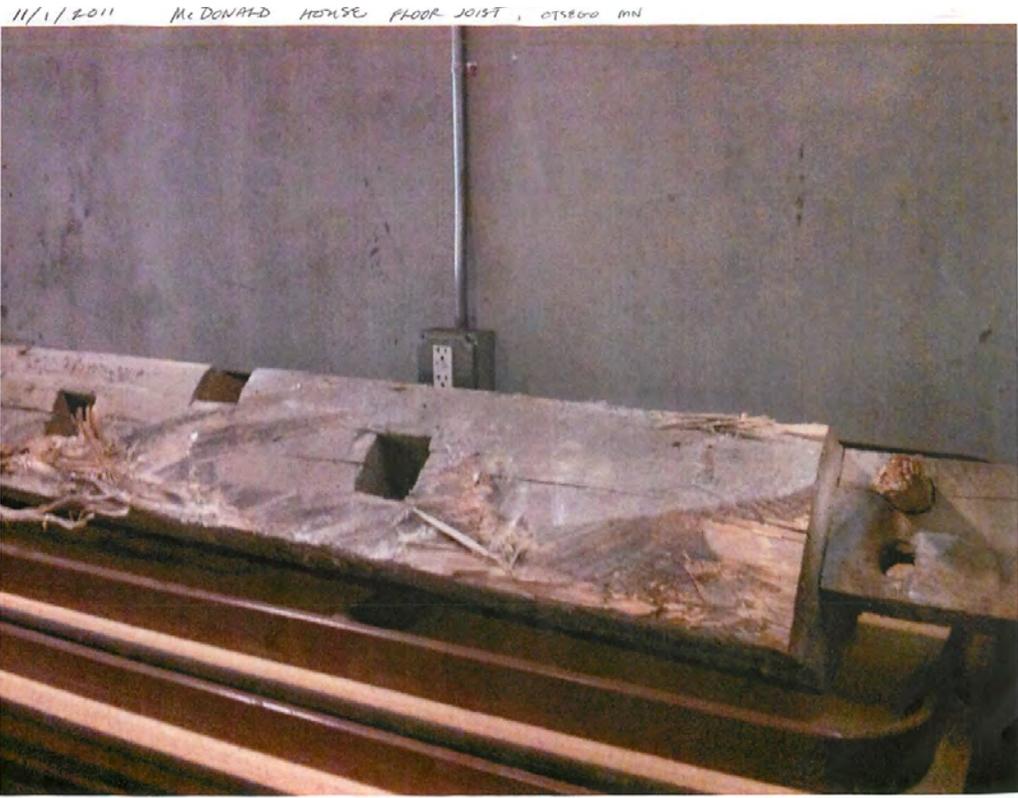
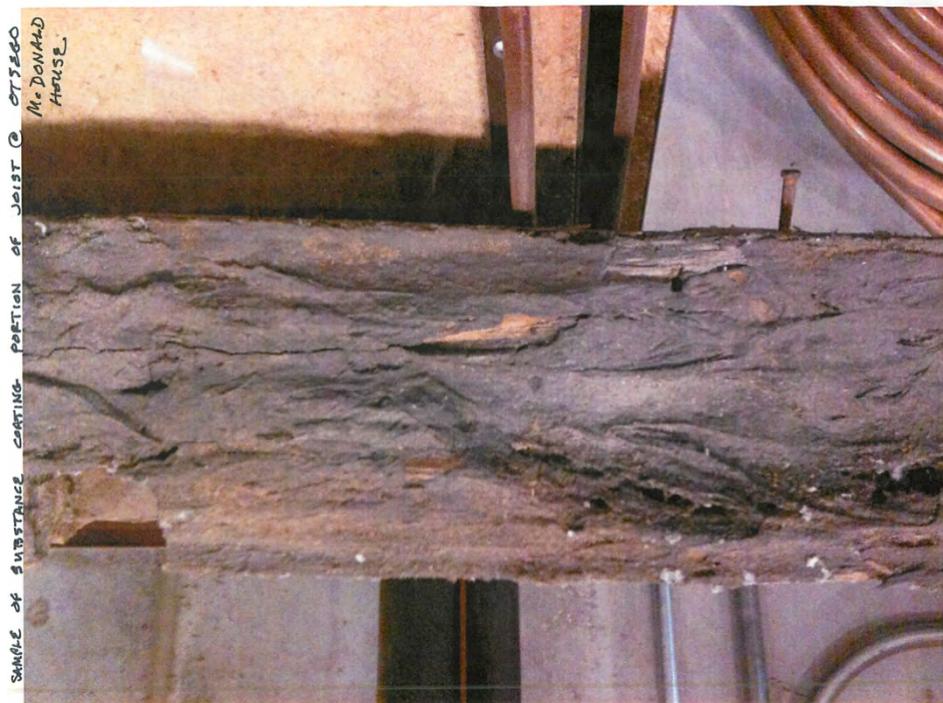
A large floor beam was recovered by Chris Wilson of the Heritage Preservation Commission at the time of demolition (Figures 17 and 18). The joist was found to be coated with a black material, probably creosote of coal-tar. Such treatments were commonly intended to preserve wood from decay.

Figure 17: Floor Joist (Photo by Chris Wilson)

Figure 18: Floor Joist Coating (Photo by Chris Wilson)

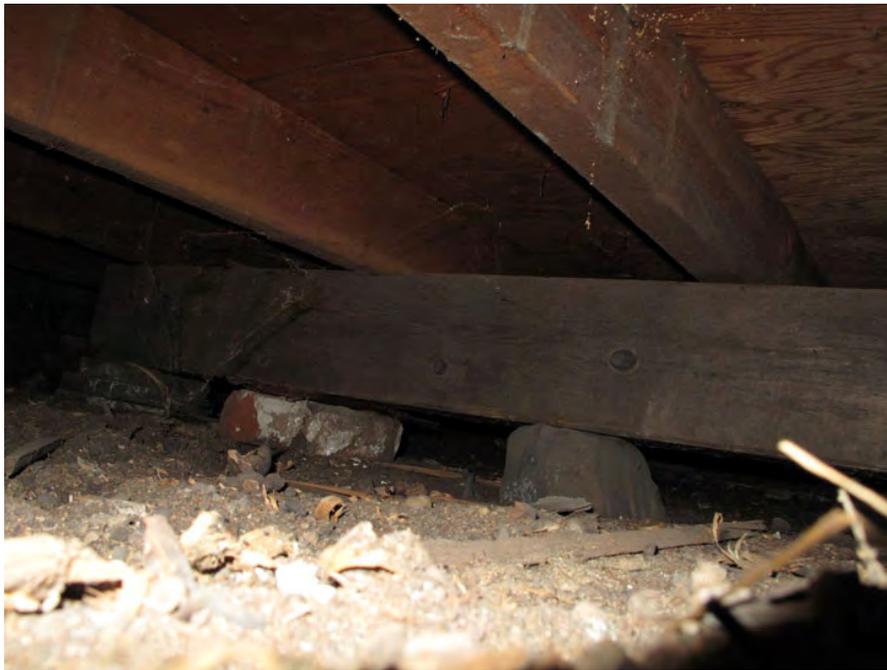
*Floor:* No original flooring was investigated (the floor in the south room was two 2" sheets of plywood, probably to be associated with the reconstruction of the southeast corner of the house). A hole was cut through the two 2" sheets of plywood that replaced the floor in the south room. The original floor joists were in place; most were rough cut 2"x4"s, some were rough cut 4"x4"s. The joists were resting on large 4"x4" subfloor beams. These beams were resting on large rocks and bricks, which themselves were resting on bare ground.

Figure 19: Phase I Subfloor and Joists

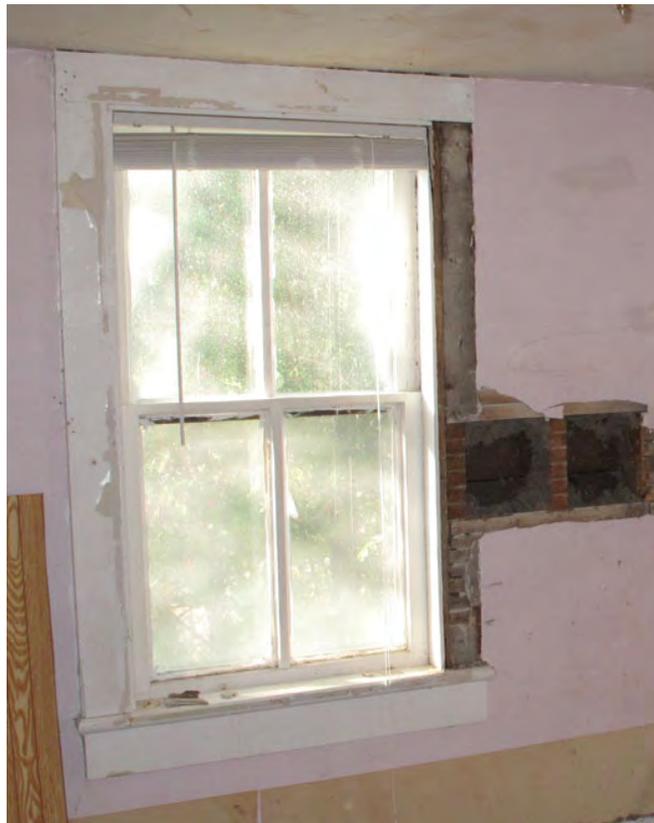
*Windows:* Windows were present centered on the north and south walls. The windows were smaller than those on the ground floor and the existing 2/2s were probably original.

Figure 20: Phase I South Window, Upper Floor

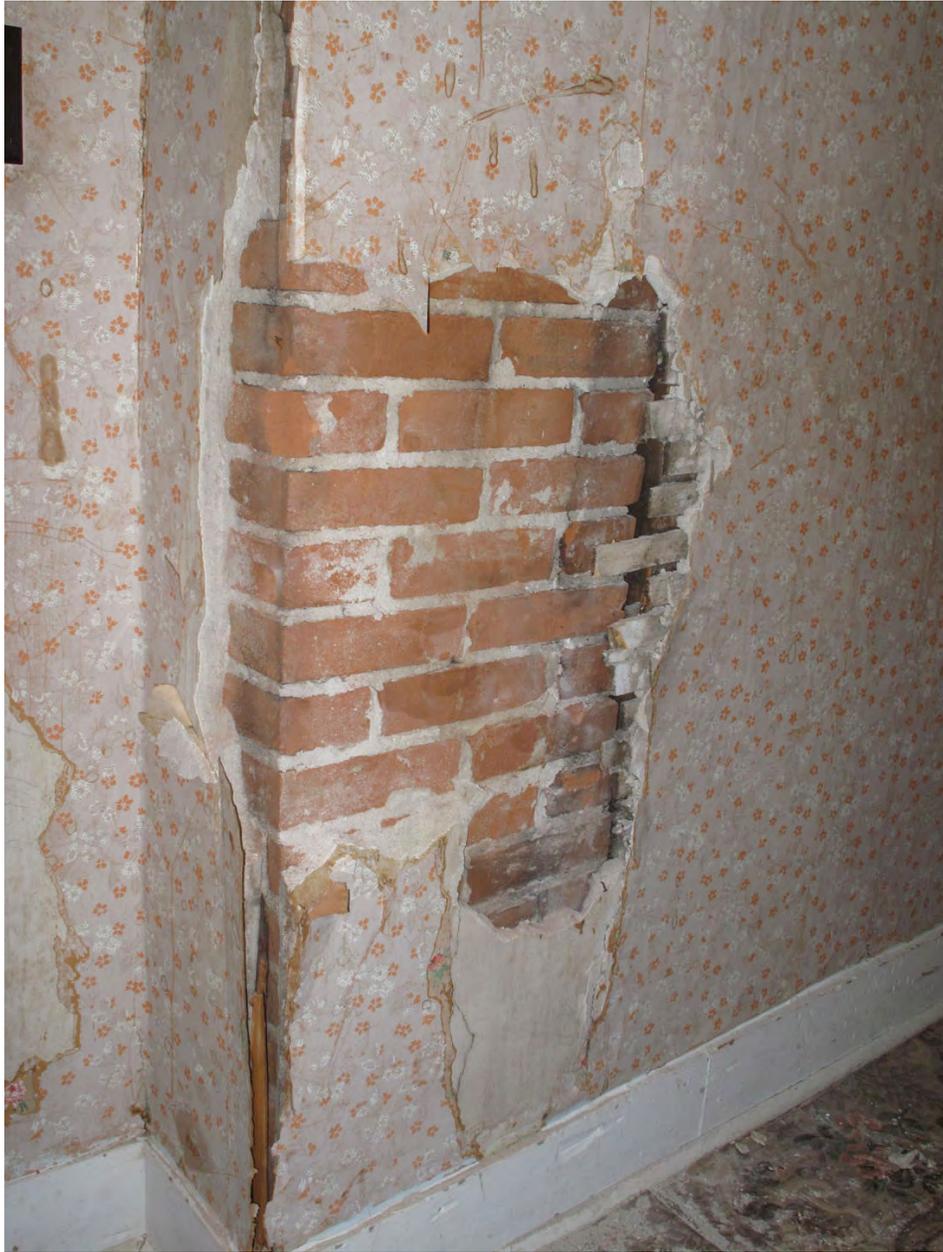
*Chimney:* The chimney is incorporated into and forms an offset corner of the dividing wall. It is constructed of red brick of unknown origin.

Figure 21: Phase I Chimney, Upper Level

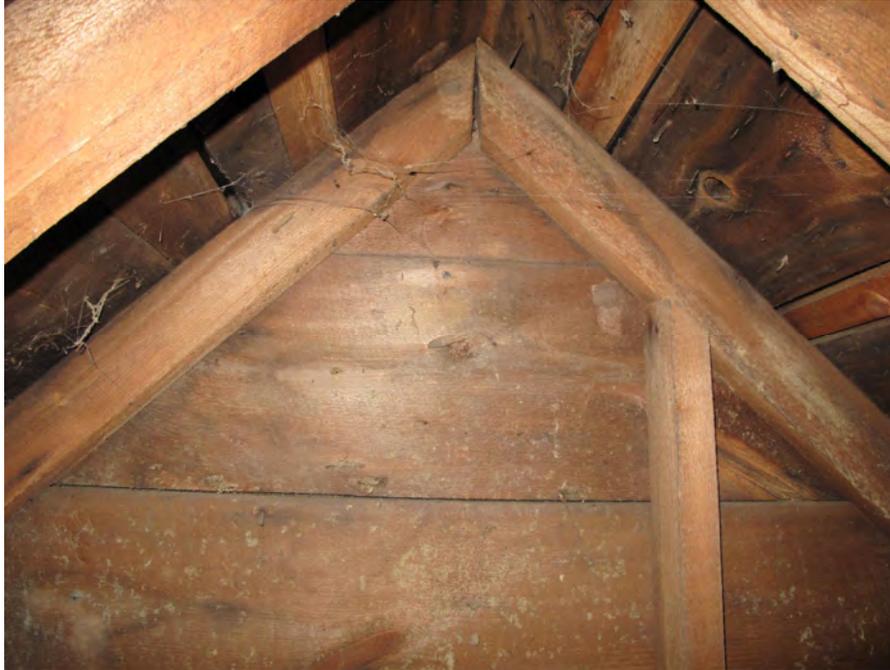
*Roof/Attic:* A small attic space is preserved above the upper floor. The roof joists are abutted instead of attached to a ridge post; this is a non-standard construction technique.

Figure 22: Phase I Roof and Gable, Interior

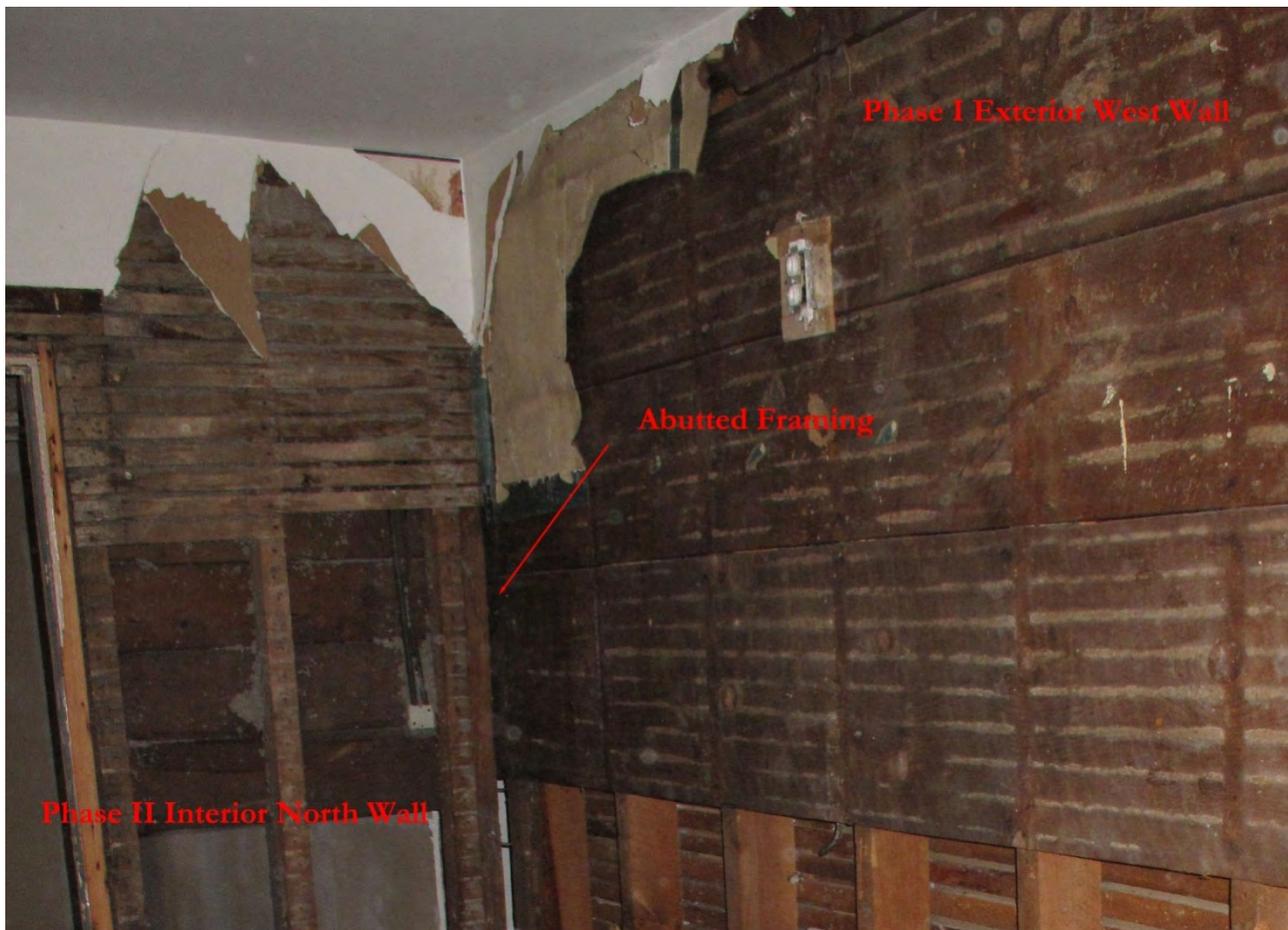
The house was expanded between 1898 and 1905 with an addition of a room on the northwest corner. The dimensions of the house at this period were 33' 4" (E-W) x 20' (N-S). The lumber and exterior finishing of Phase II is almost identical with Phase I. The use of rough cut dimensional lumber suggests a date prior to c. 1905, as finished lumber becomes common about that time. The Phase II addition was not known prior to our investigation. The addition was indicated by the slightly different roof lines on the exterior. Deconstruction of the house revealed that the balloon framing of the addition abutted the Phase I structure. Additionally, the exterior of the west wall of the Phase I structure was originally covered with tar paper and shingles, indicating it was definitely an exterior surface.

Figure 26: Phase I and II Abutted Framing

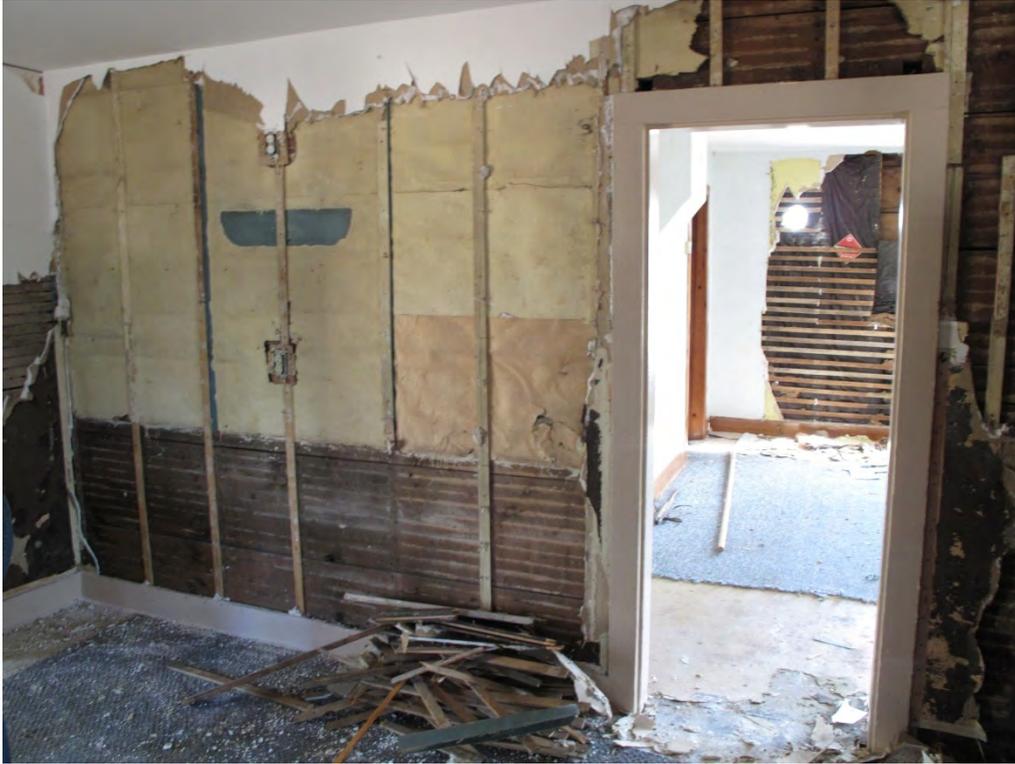
Figure 29: Interior East Wall, Phase II Addition (wall paper is later)

The house was expanded and modified more than once after Phase II. The details of these modifications were not fully documented, and have been lumped together in Phase III. The front porch was enclosed, and a new entrance placed on the west wall, southwest corner. A large two room addition was added to the north side of the house. A cellar was added in the northwest corner of the house. The plaster was removed from interior walls, and walls were covered with paper. Some of the paper was painted (see Figure 29).

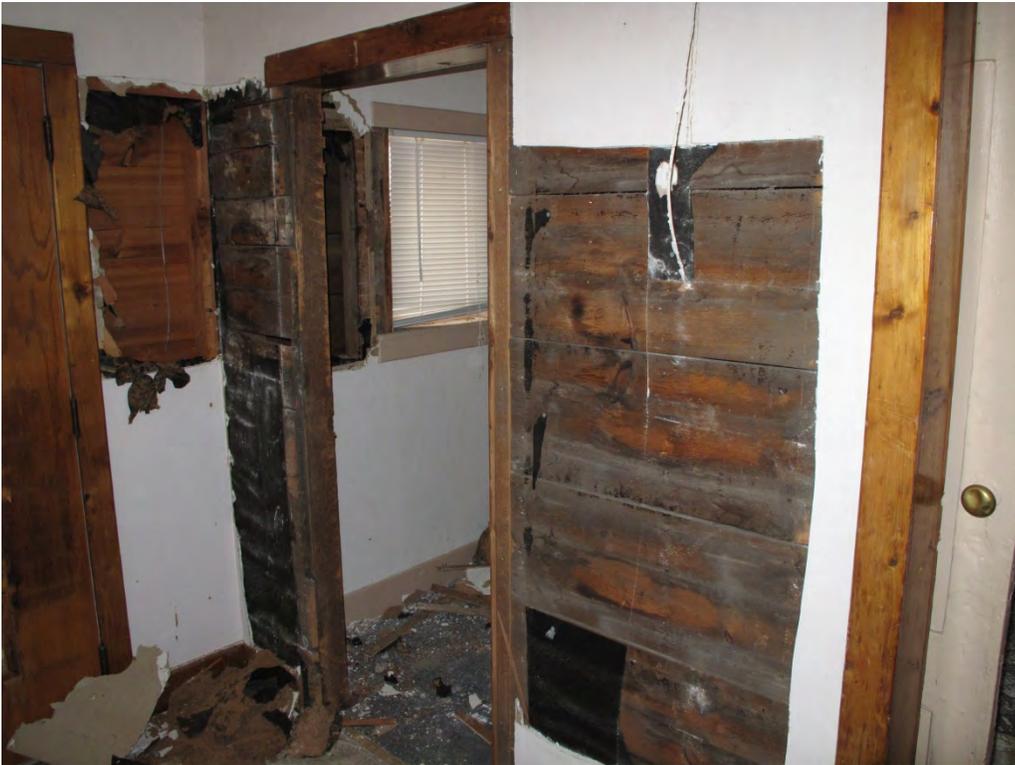
Figure 30: Exterior Wall and West Doorway, Phase II

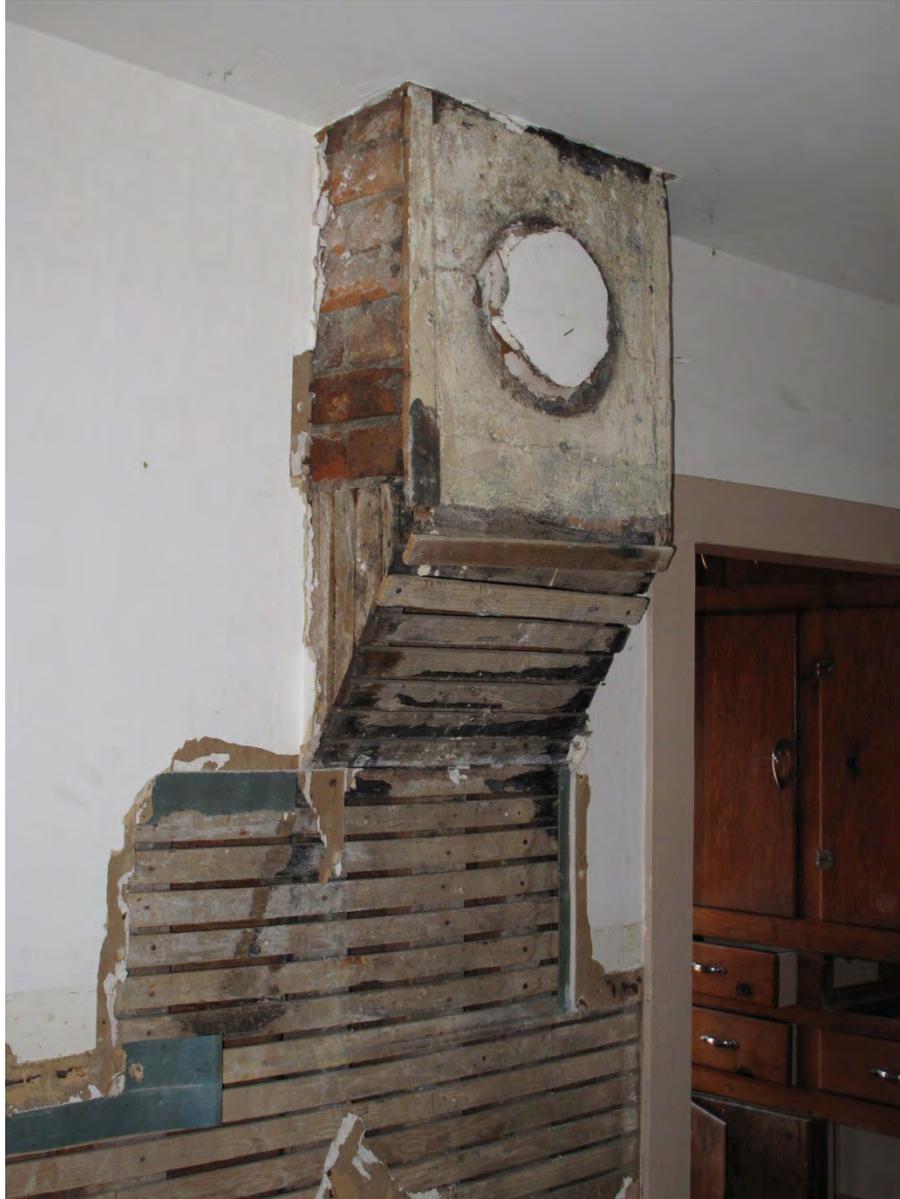
Figure 31: Perched Chimney, Phase II Addition
